# BUILDING-STRUCTURE INVENTORY FORM

1. BUILDING NAME(S): Allen House  
2. COUNTY: Monroe TOWN/CITY: Greece VILLAGE: ---  
3. STREET LOCATION: 70 Edgemere Drive  
4. OWNERSHIP: a. public ☐ b. private ☒ 765 Elmgrove Rd.  
5. PRESENT OWNER: Michael Cavalcanti ADDRESS: Rochester, NY 14624  
6. USE: Original: residence Present: residence  
7. ACCESSIBILITY TO PUBLIC: Exterior visible from public road: Yes ☒ No ☐  
Interior accessible: Explain private residence

Town of Greece Historic Sites Survey  
Monroe County, New York  
70 Edgemere Drive  
page 5

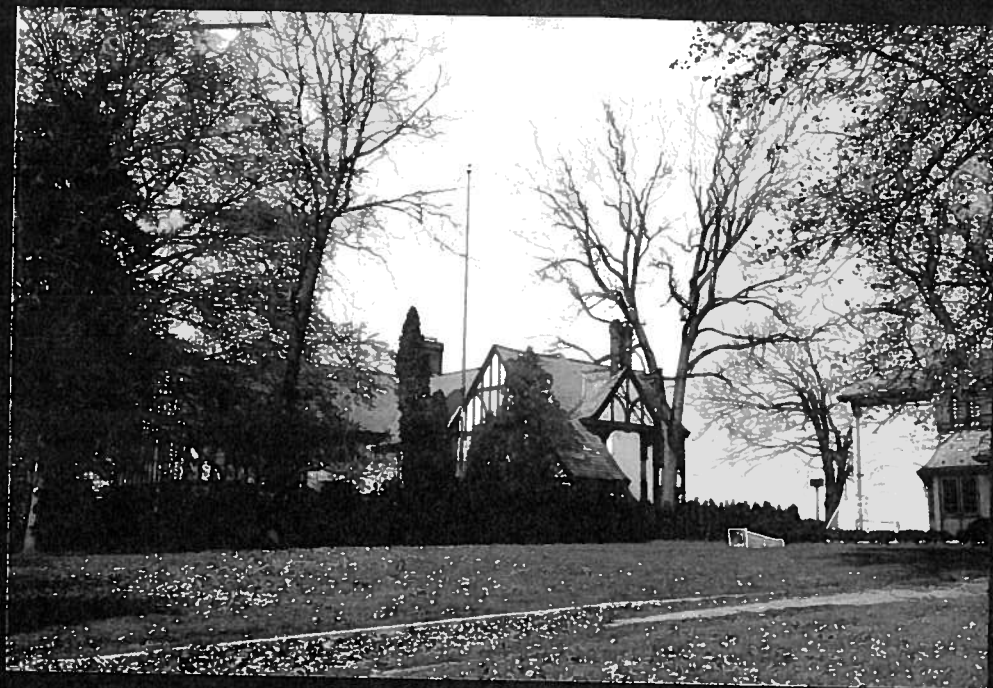
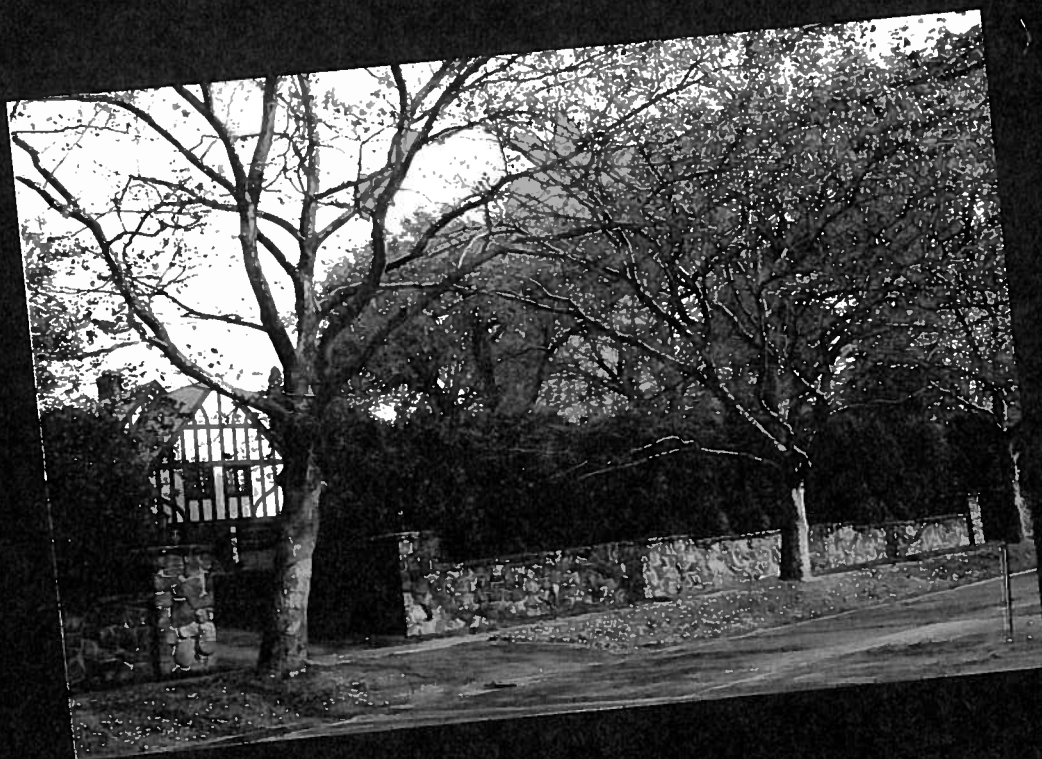
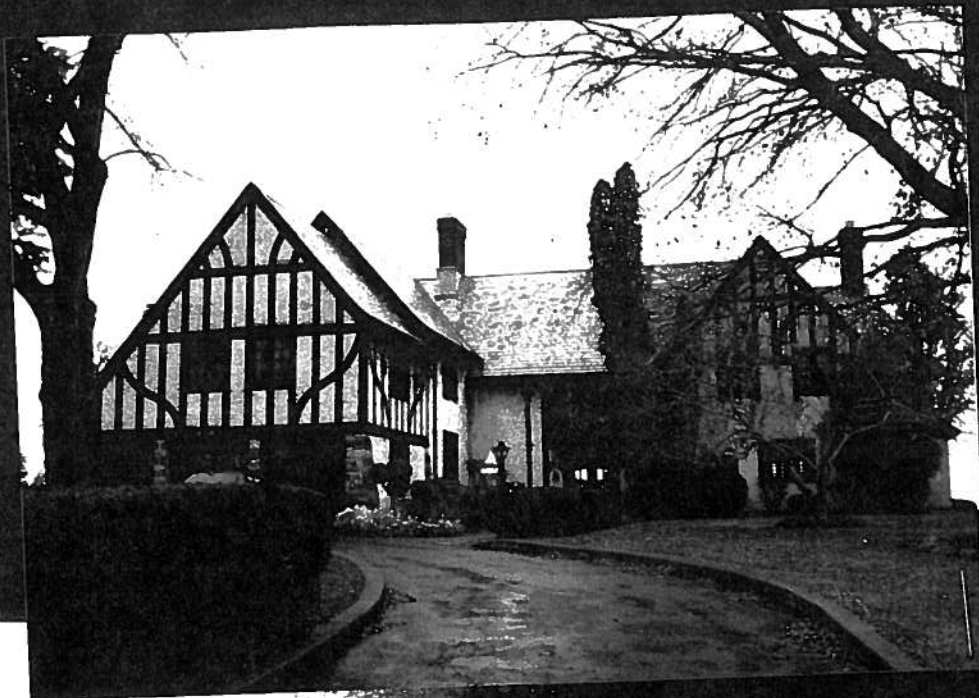
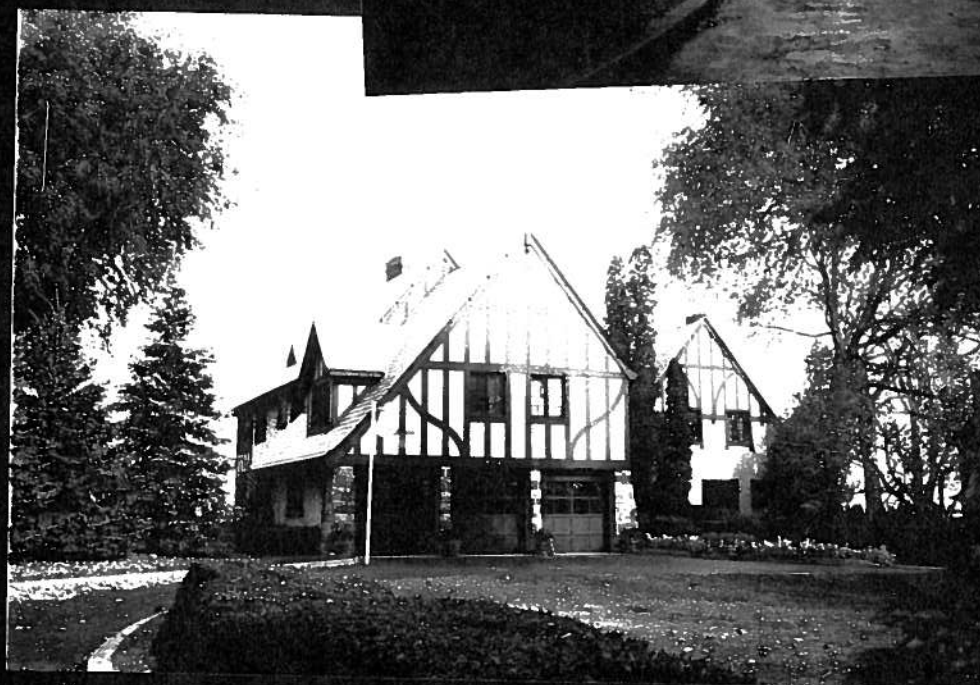
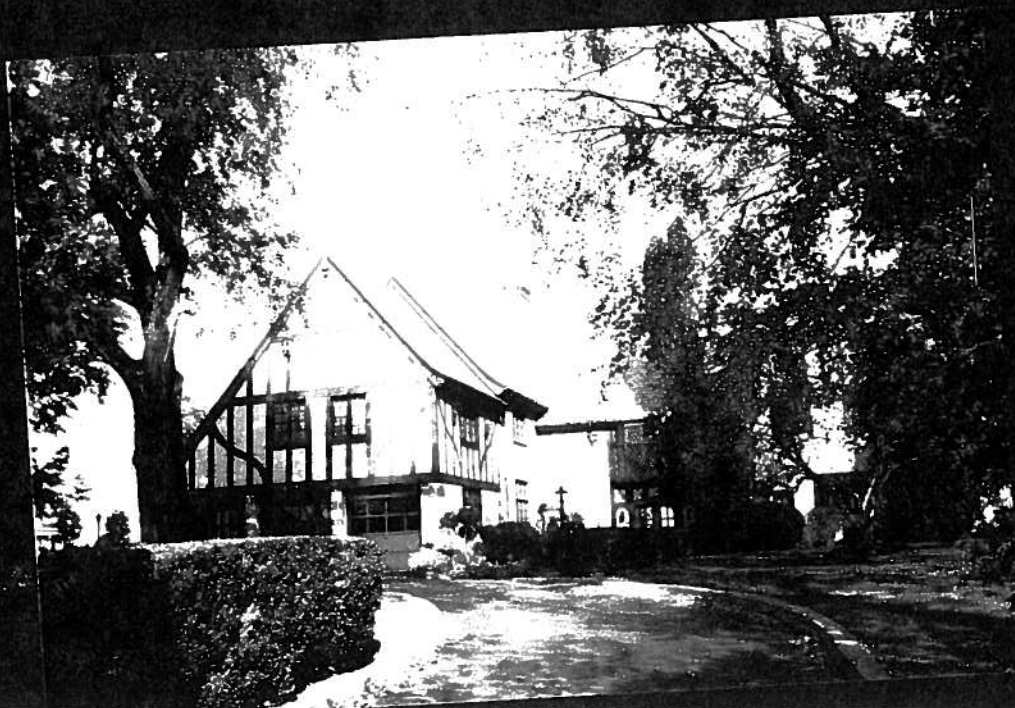
12. PHOTO:

18. This c. 1924 - 1930 Tudor Revival house is a large, two-story residence featuring an ell plan, stucco veneer exterior, slate roof and large expanses of half-timbered detailing. On the main east-west ridgeline of the roof are two large, corbelled, brick chimneys with stucco bases and ceramic chimney pots.

The dominant front gable wing extends forward (south) and features a double-gabled (one higher than the other) roof design. It has regular fenestration with 6-paned, steel casement windows hung in pairs. The wall surface of the upper half of the facade and east elevation is finished in half-timbered cladding. The facade (with three garage doors) has stone detailing on the corners and in between the doors.

The main, east-west section of the house is recessed from the front gable wing. Its facade features a prominent gable with half-timbered detailing and 6-paned, steel casement windows hung in two's and three's. The center entrance features a double door (glazing in the upper half) that is surrounded by half-timber detailing. Above the entrance is an oriel bay window with diamond-paned leaded glass; the windows have five long sections, each topped by a square transom. Copper
